Appendix 6

Photo Log

MS4 Mapping Discrepancies – City Operations Facility at Spa Road

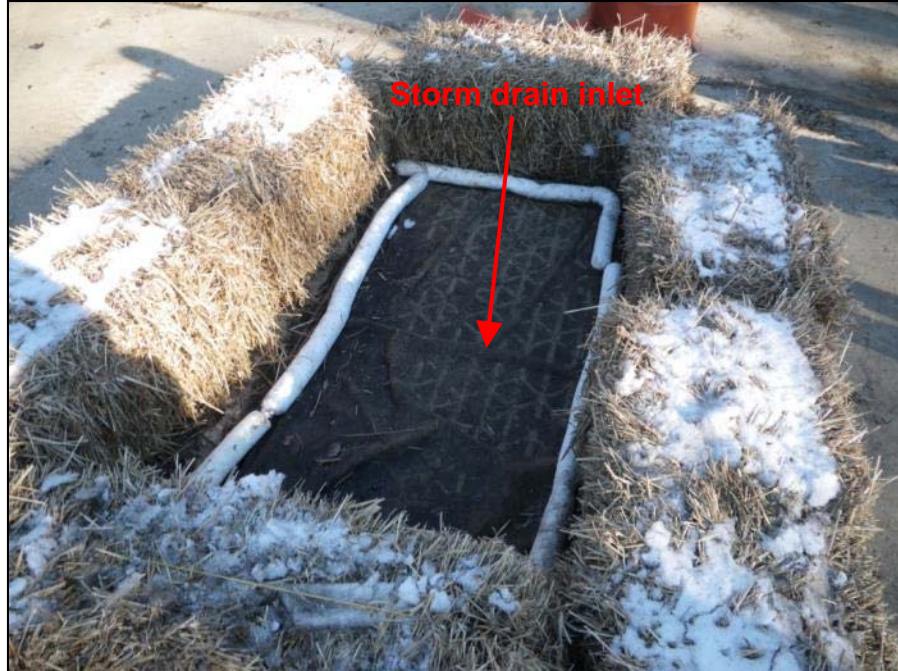
Photograph 2. View of additional storm drain inlet at the City's Spa Road Maintenance Facility that was not depicted in the City's GIS.

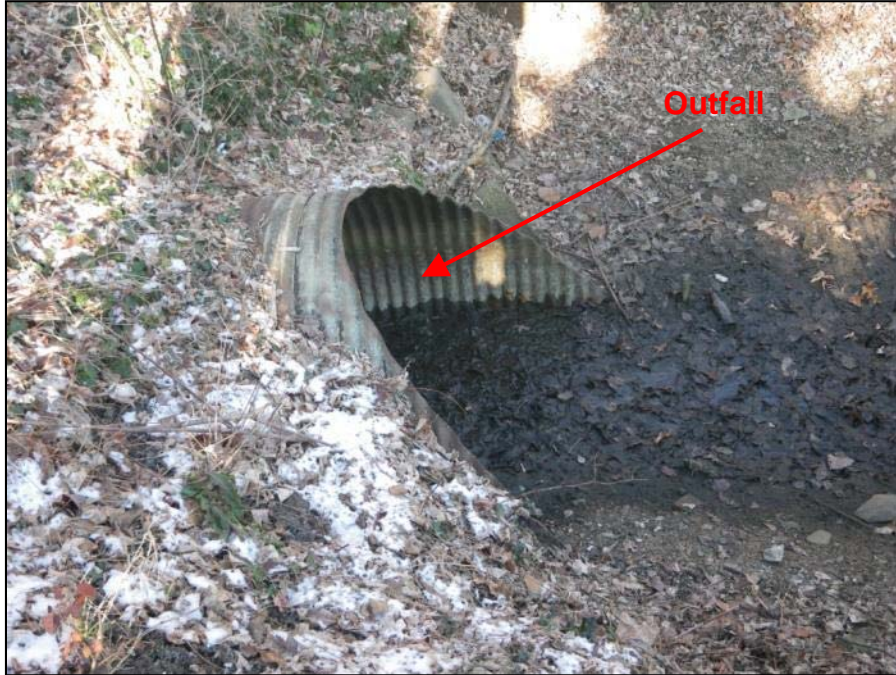
Photograph 3. View of outfall to College Creek along Ridge Avenue across from the Glenwood Senior Citizen facility.

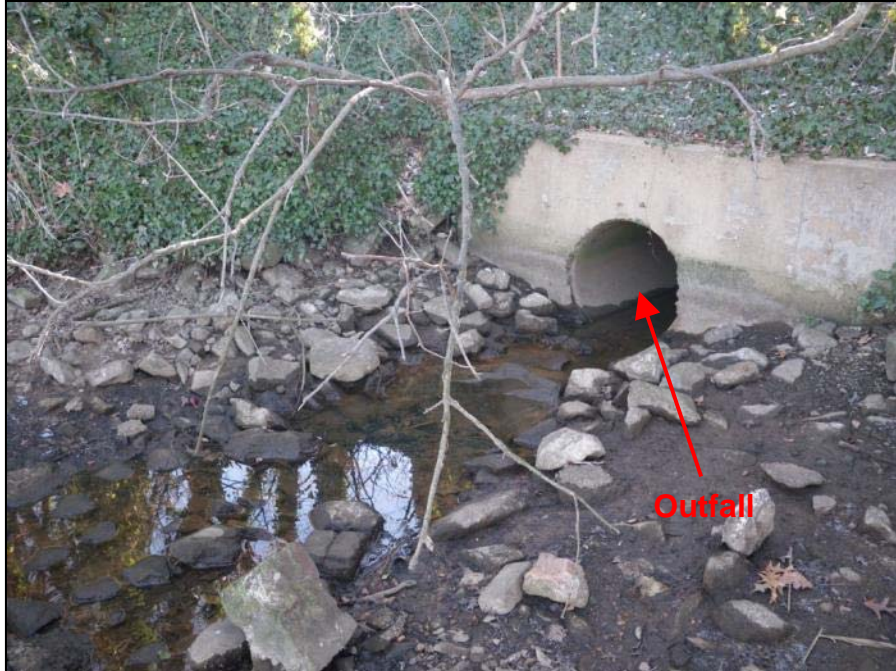
Photograph 4. View of outfall to College Creek located to the northwest of Bertina A. Nick Way.

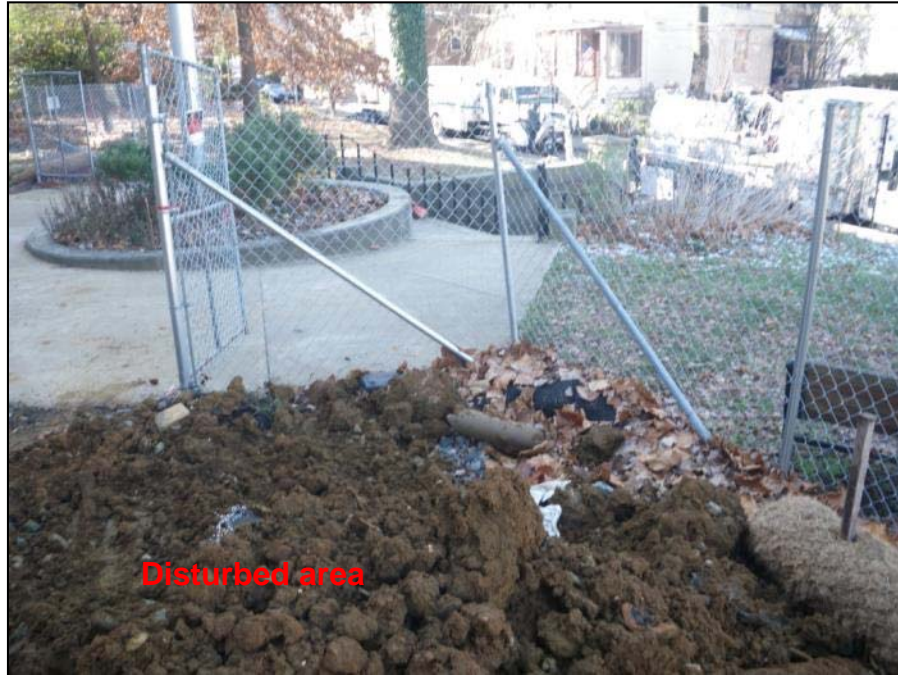
Photograph 5. View of disturbed area on the northwestern edge of the site. Note lack of perimeter control BMPs in this area.

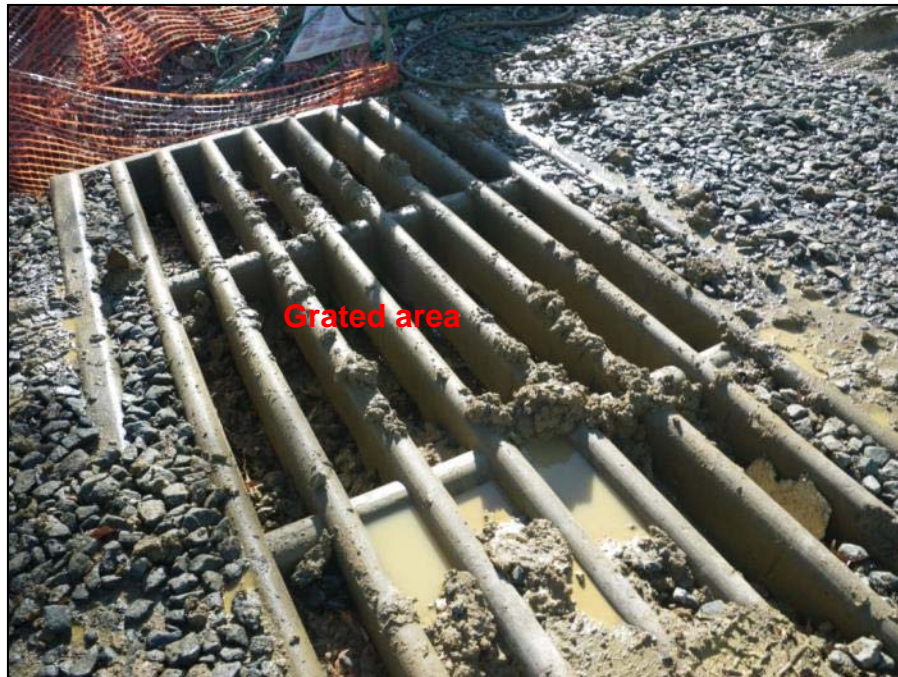
Photograph 14. View of grated area at construction entrance.

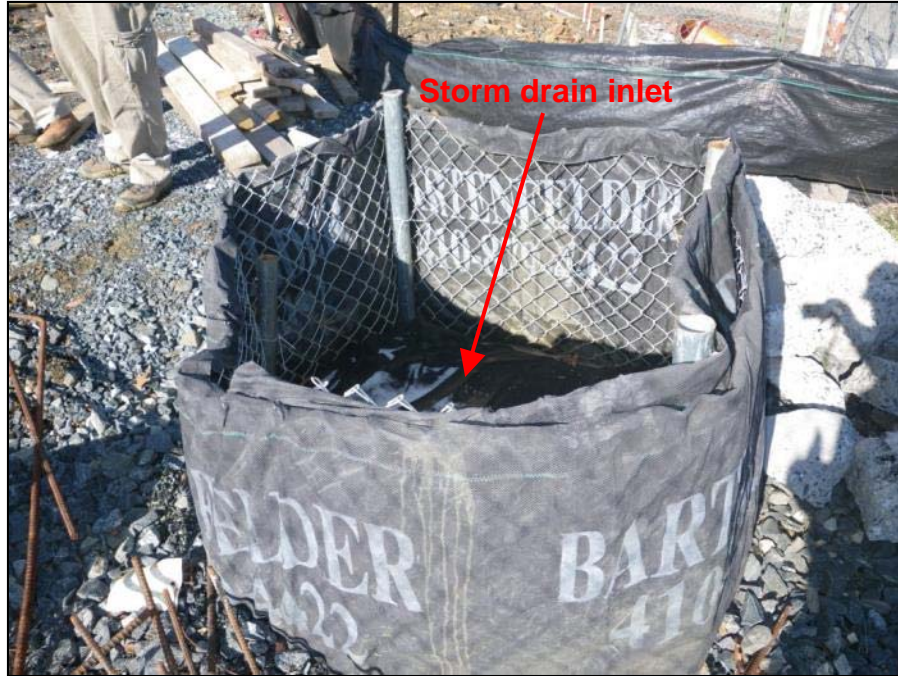
Photograph 15. View of storm drain inlet approximately 100 feet to the northwest of the construction entrance.

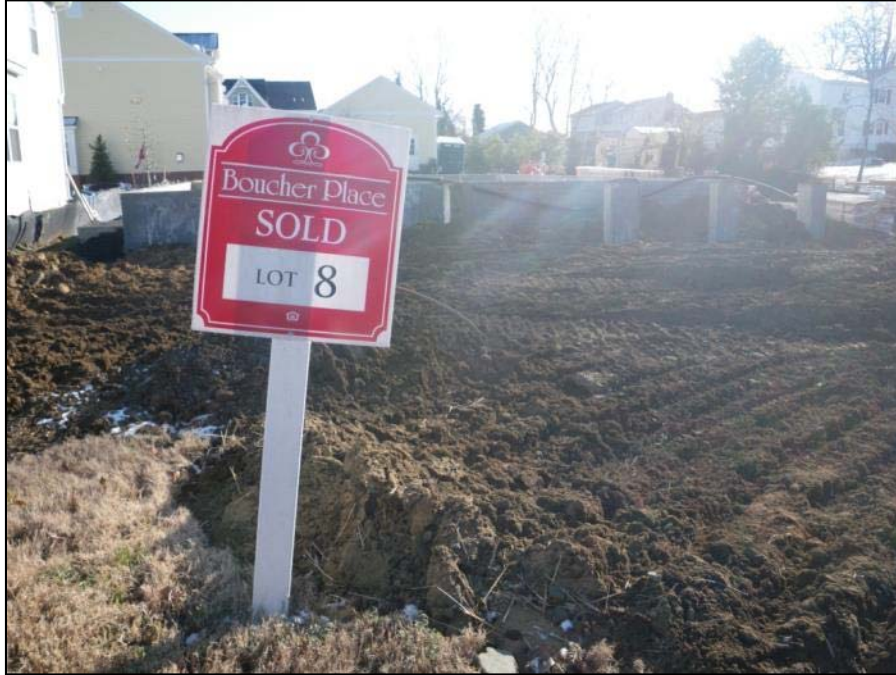
Photograph 17. View of active construction at Lot 8 located at 1109 Boucher Place at the time of the site visit.

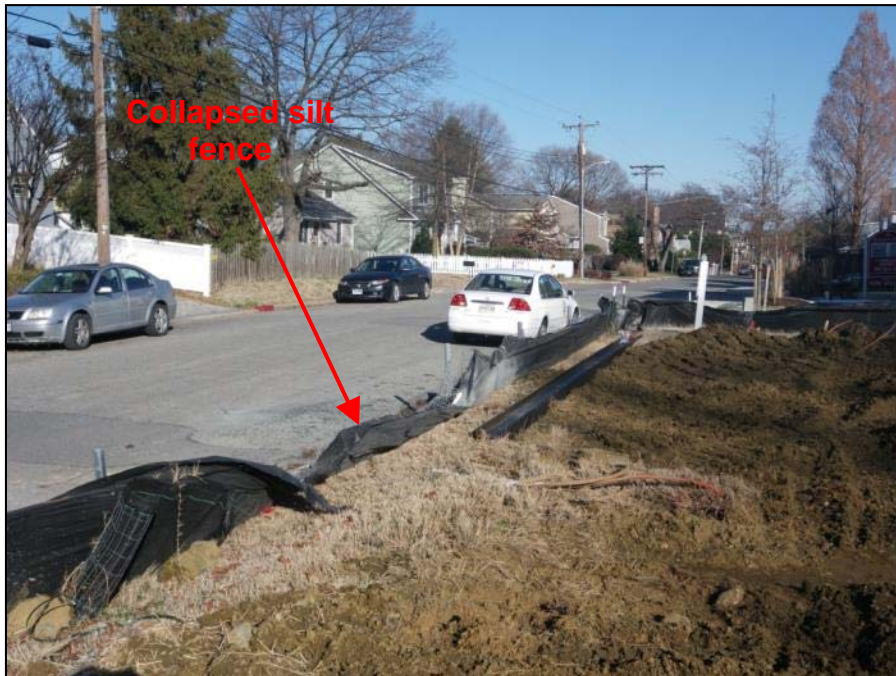
Photograph 18. View of collapsed silt fence along the northern perimeter of the site.

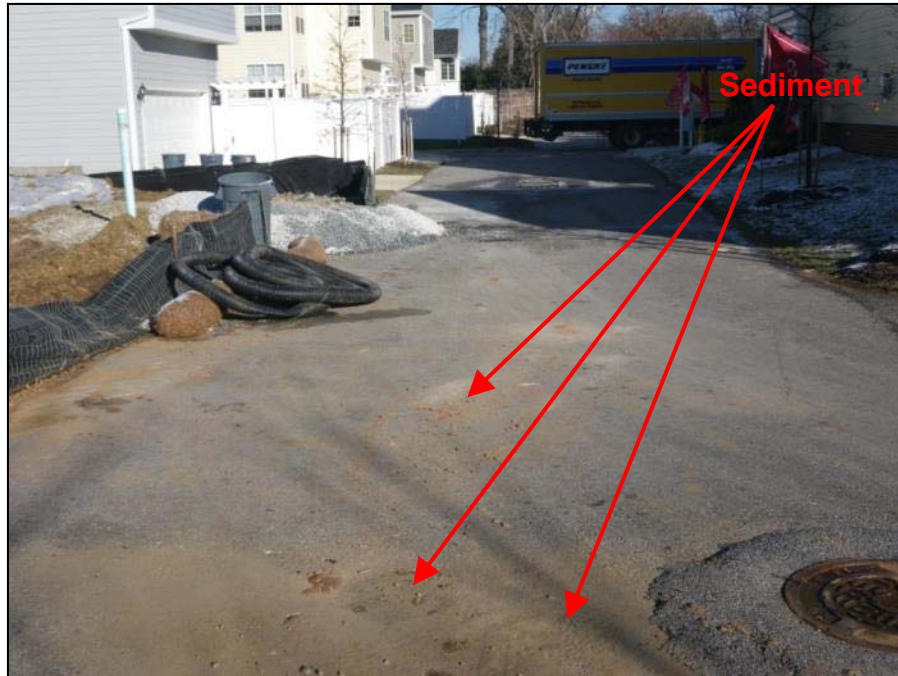
Photograph 23. View of sediment present on the impervious alley surface along the southeastern perimeter of the lot.

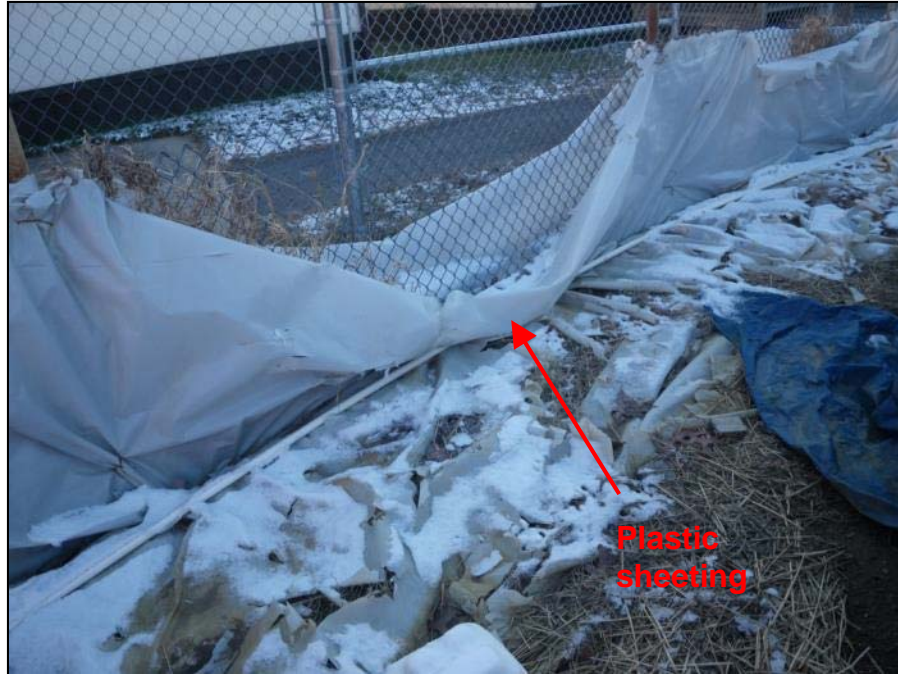
Photograph 26. Closer view of plastic sheeting material used to prevent stormwater run-on from the adjacent property in the southern portion of the site.

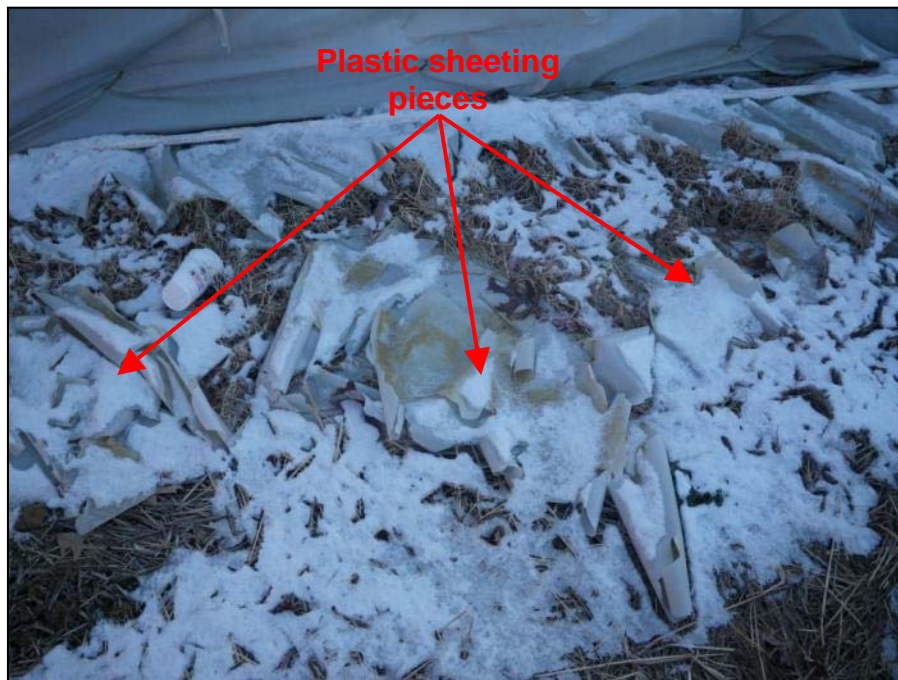
Photograph 27. Close-up view of pieces of the plastic sheeting material present on the ground surface.

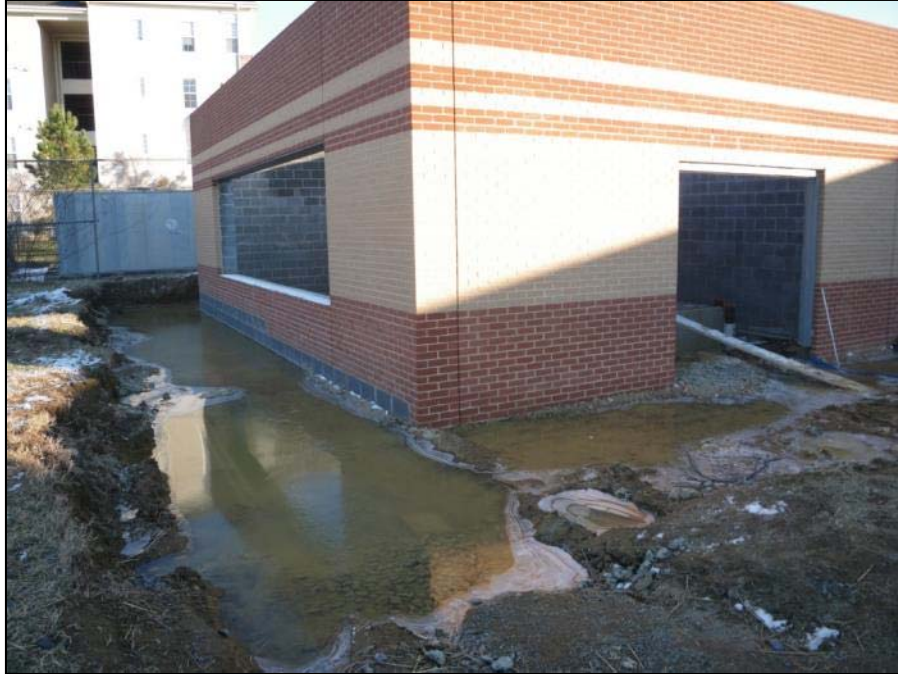
Photograph 28. View of generator room in the northern portion of the site.

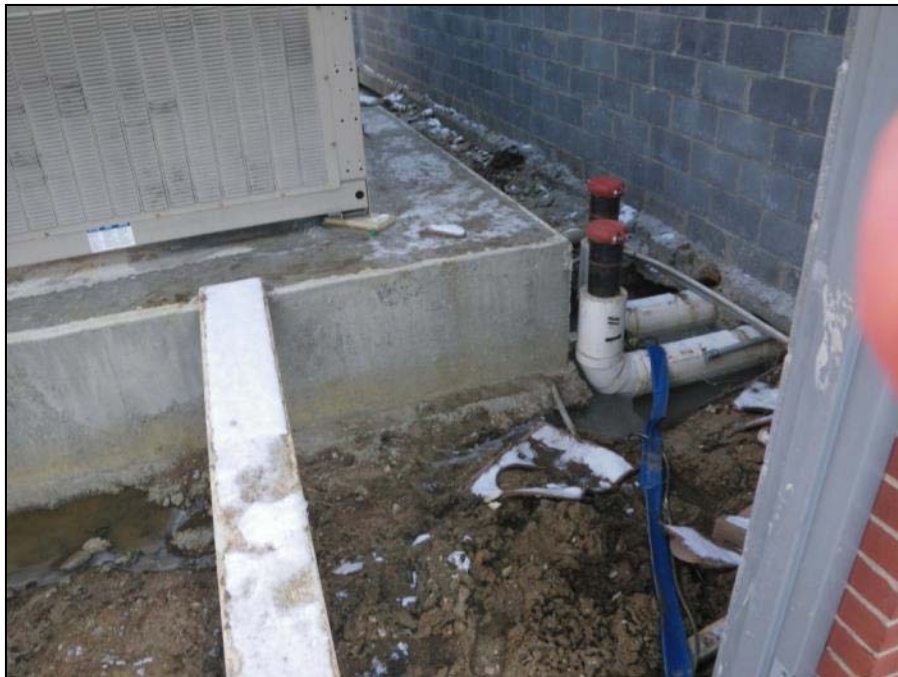
Photograph 29. Closer view of area which was dewatered in the generator room in the northern portion of the site.

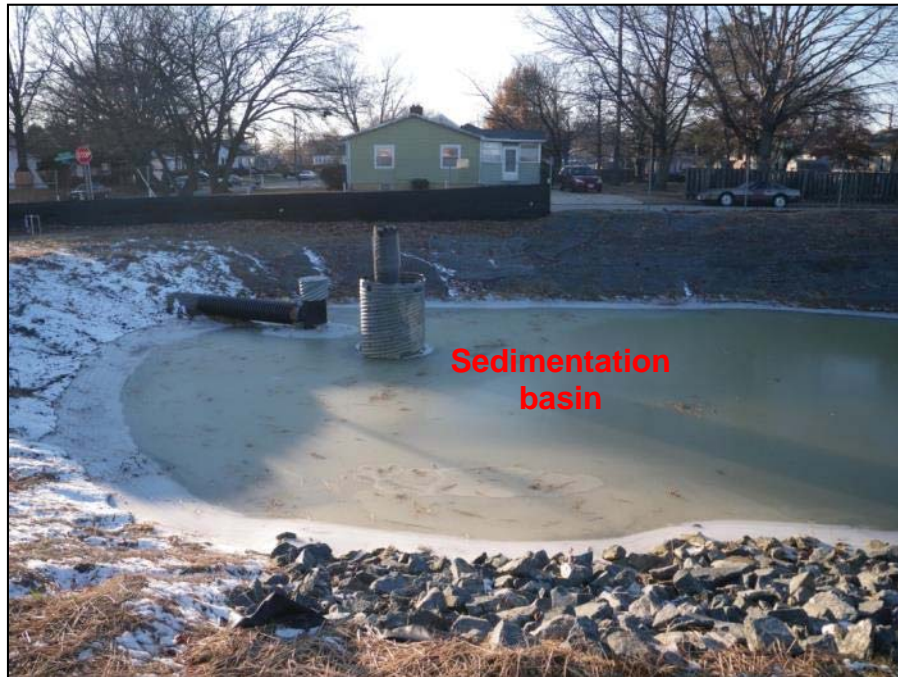
Photograph 31. View of sedimentation basin near the southwestern corner of the site.

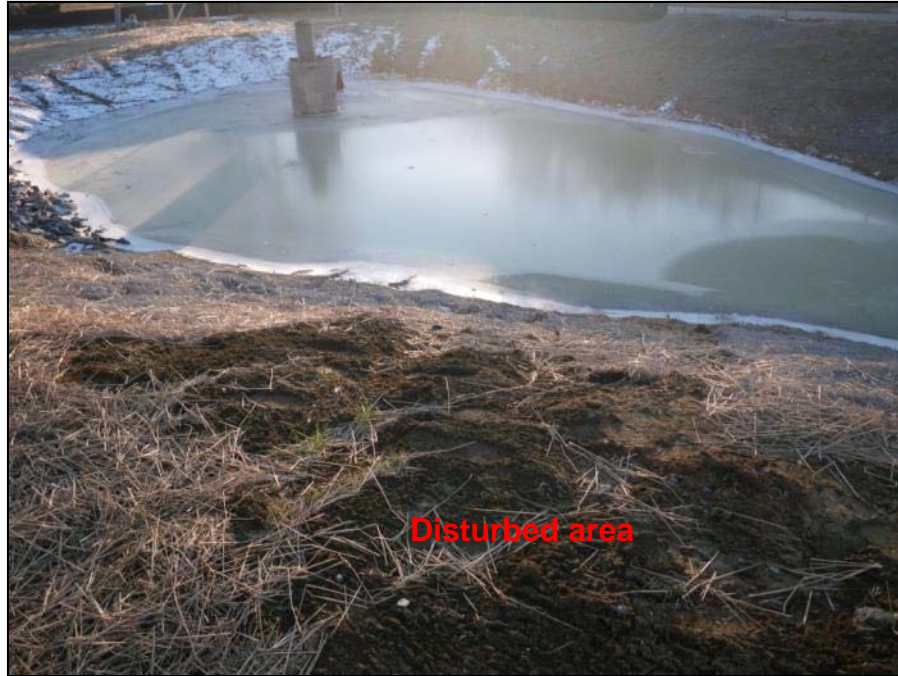
Photograph 34. View of disturbed area along the slope of the sedimentation basin.

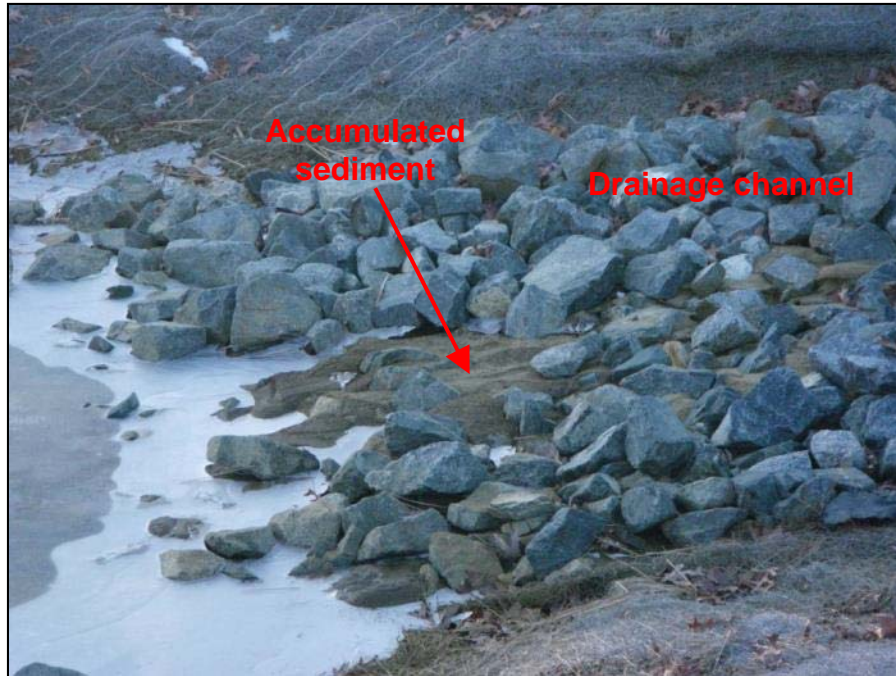
Photograph 36. Closer view of accumulated sediment in the rock-lined drainage channel into the basin on its northern side.

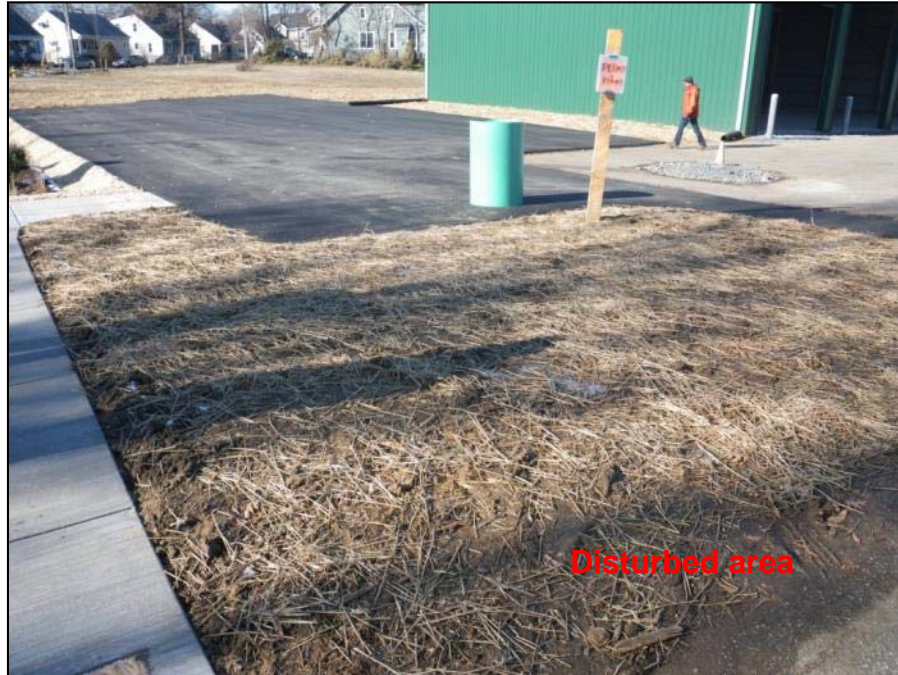
Photograph 37. View of disturbed area with inadequate coverage.

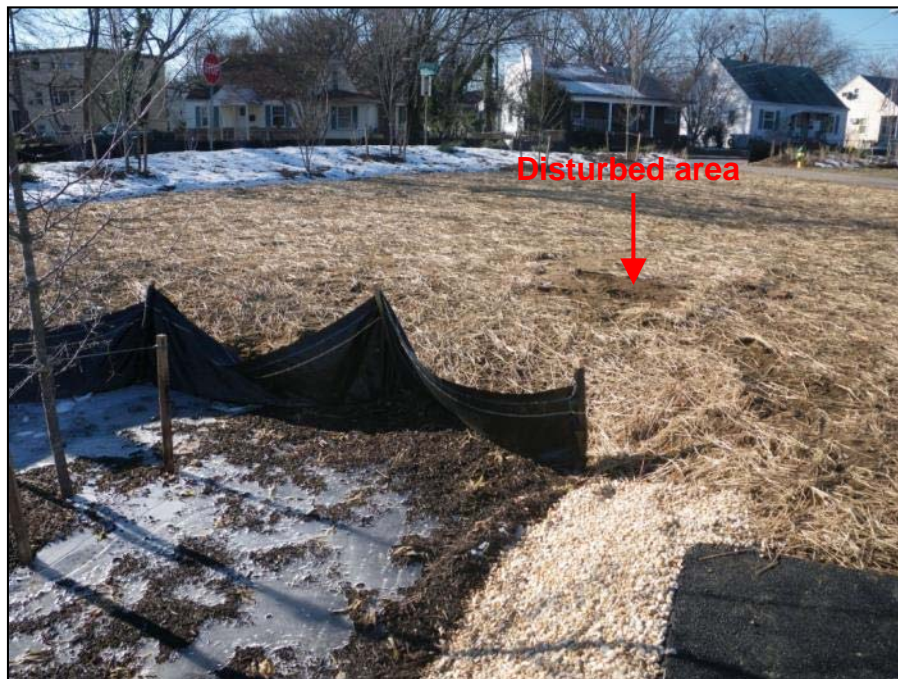
Photograph 38. Additional disturbed area with inadequate coverage.

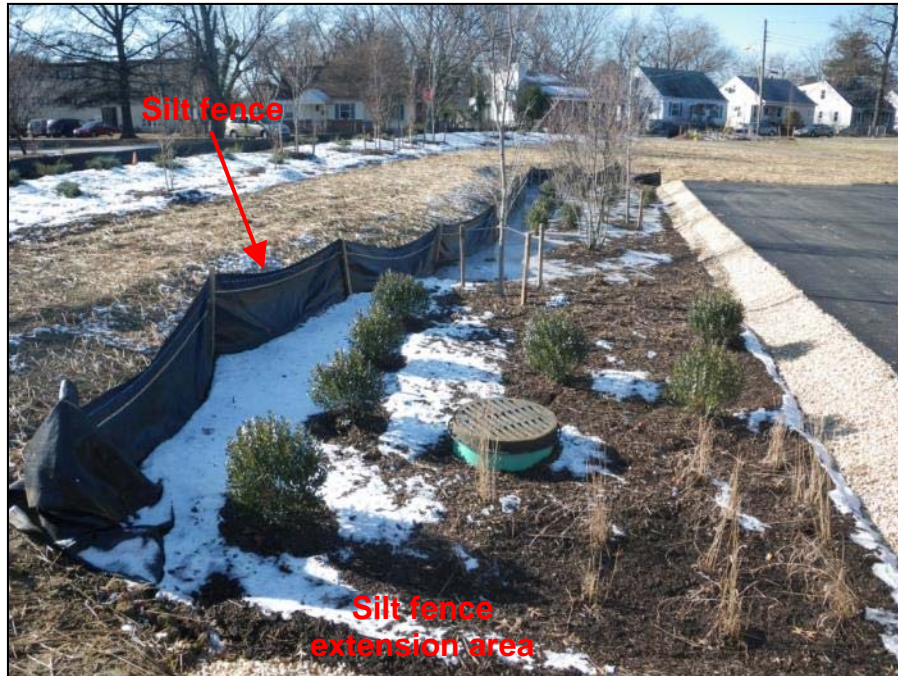
Photograph 39. View of area where the silt fence should be extended on the southeastern side of the rain garden in the southern portion of the site.

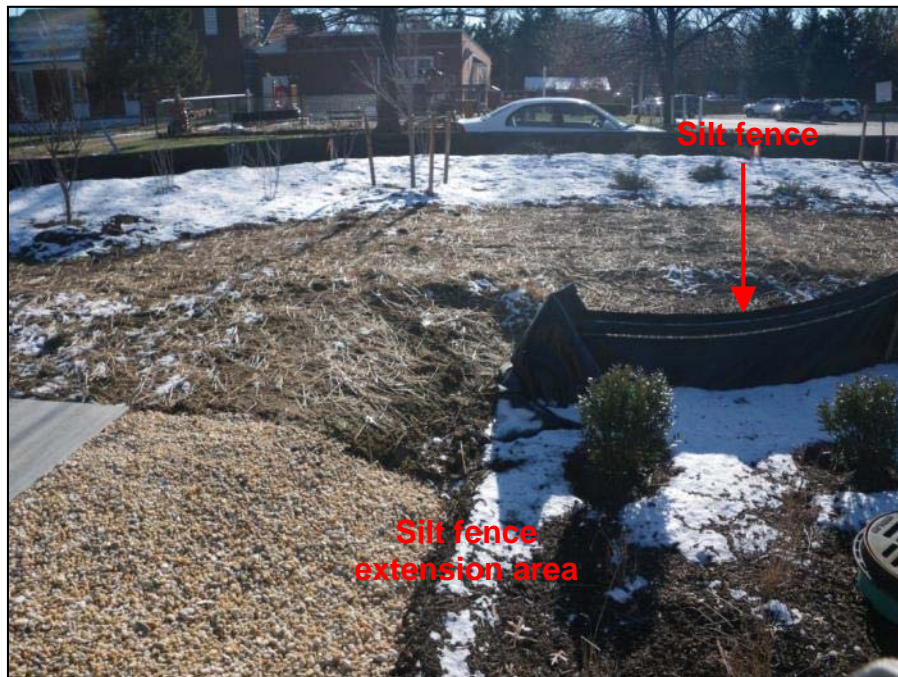
Photograph 40. Additional view of area where the silt fence should be extended on the southeastern side of the rain garden in the southern portion of the site.

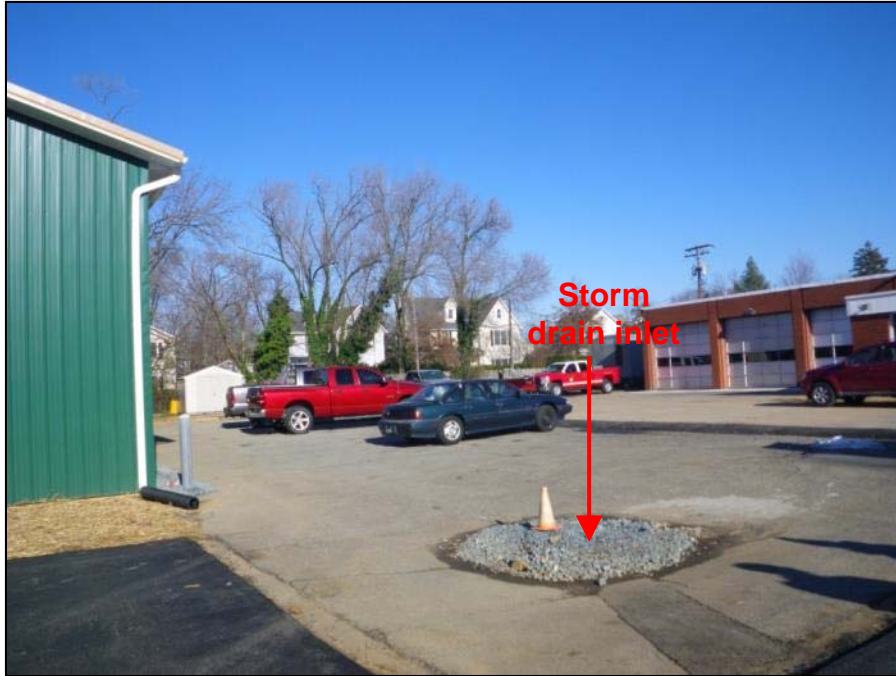
Photograph 41. View of rock used for storm drain inlet protection in the impervious parking area.

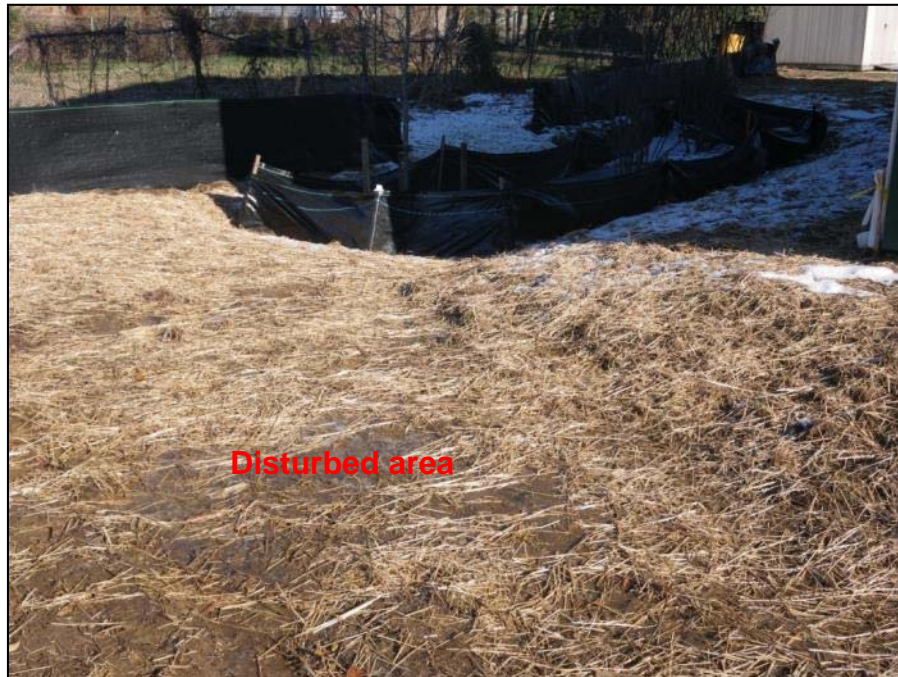
Photograph 44. View of disturbed area upgradient of the rain garden on northern side of the new storage structure.

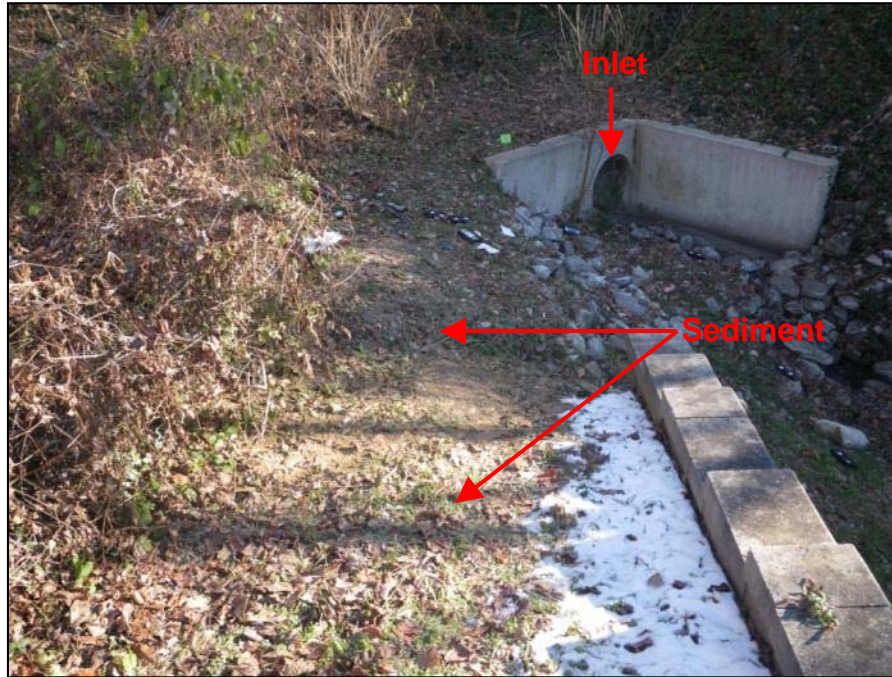
Photograph 45. View accumulated sediment along a slope near the northern inlet to the pond.

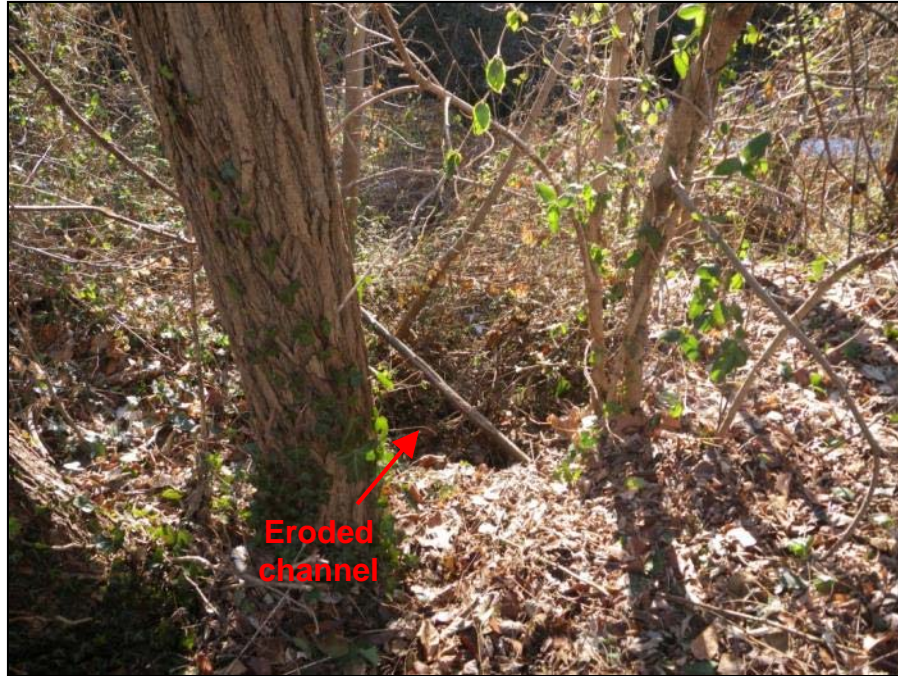
Photograph 47. View of eroded channel upgradient of accumulated sediment shown in previous photographs. Note that the channel is difficult to discern in the photograph due to the presence of vegetation and leaves on the ground surface.

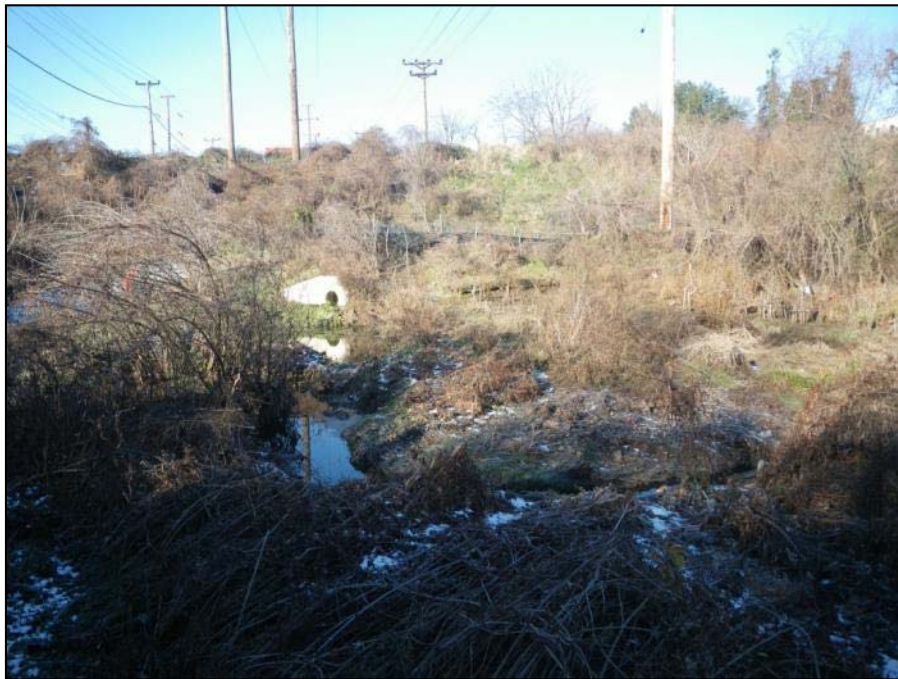
Photograph 48. View of interior of stormwater management pond. Note vegetation within the pond.

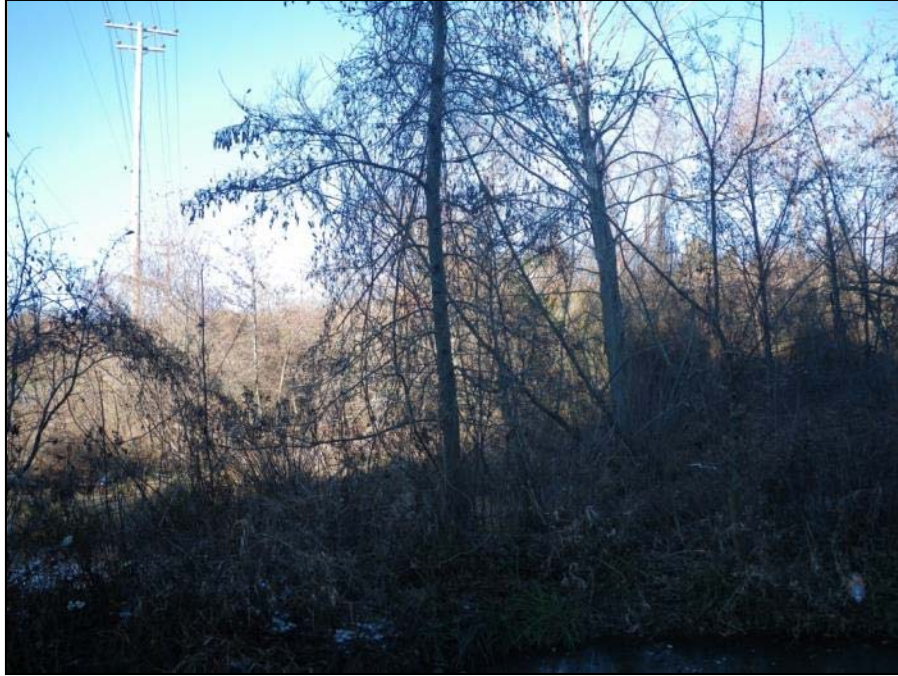
Photograph 49. Additional view of interior of stormwater management pond. Note vegetation within the pond.

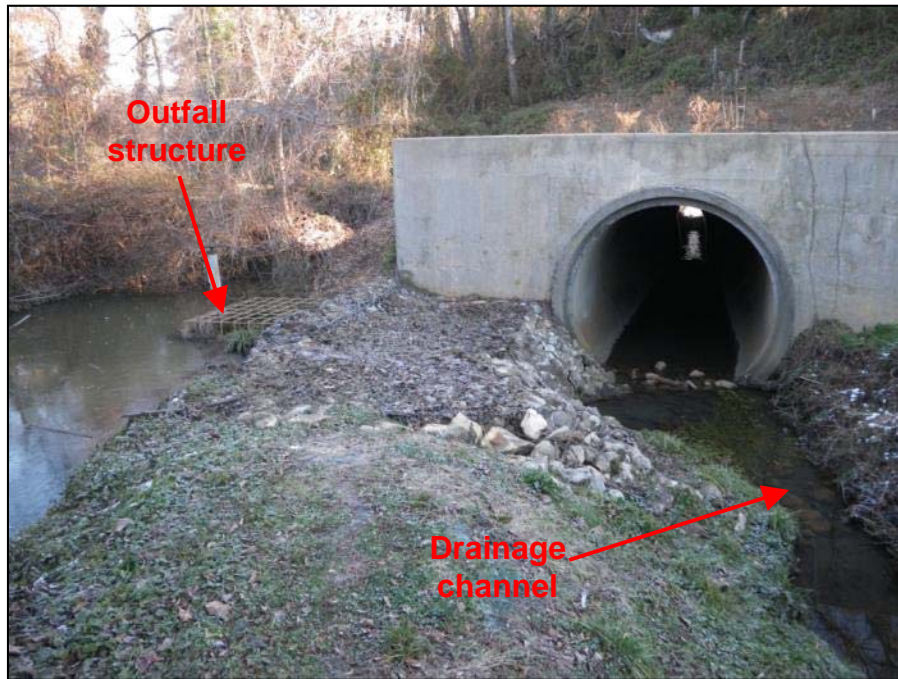
Photograph 50. View of primary outfall structure to adjacent drainage channel to College Creek.

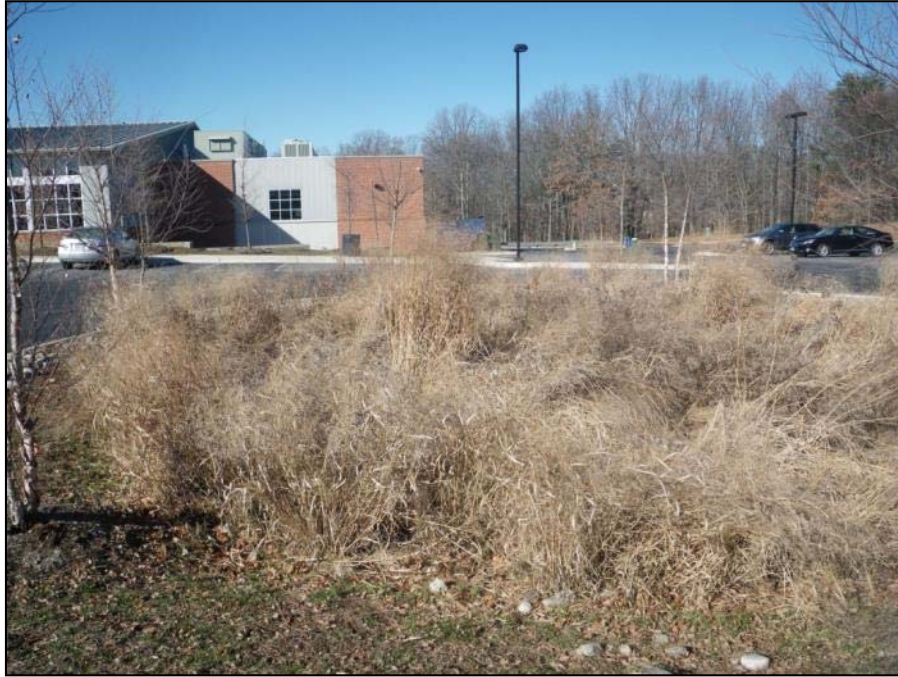
Photograph 51. View of landscape infiltration basin or “rain garden.”

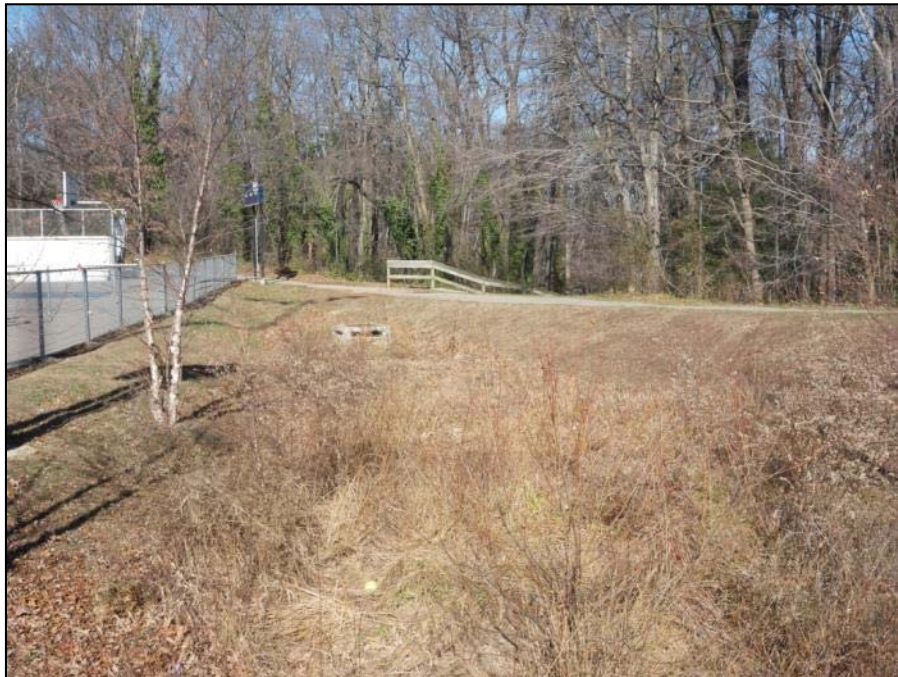
Photograph 52. View of additional landscape infiltration basin.

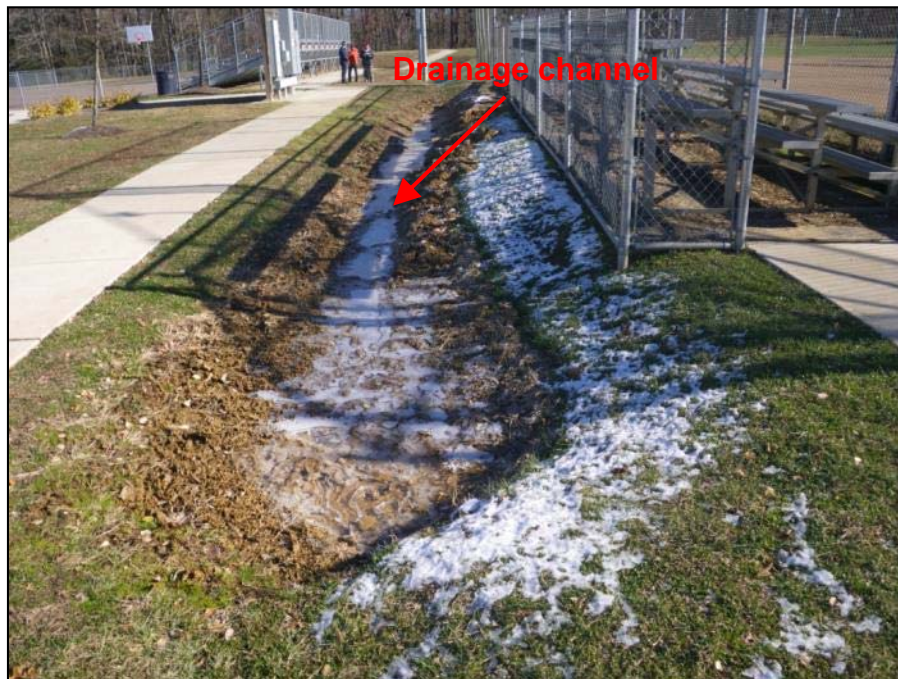
Photograph 54. Additional view of drainage shown in previous photograph.

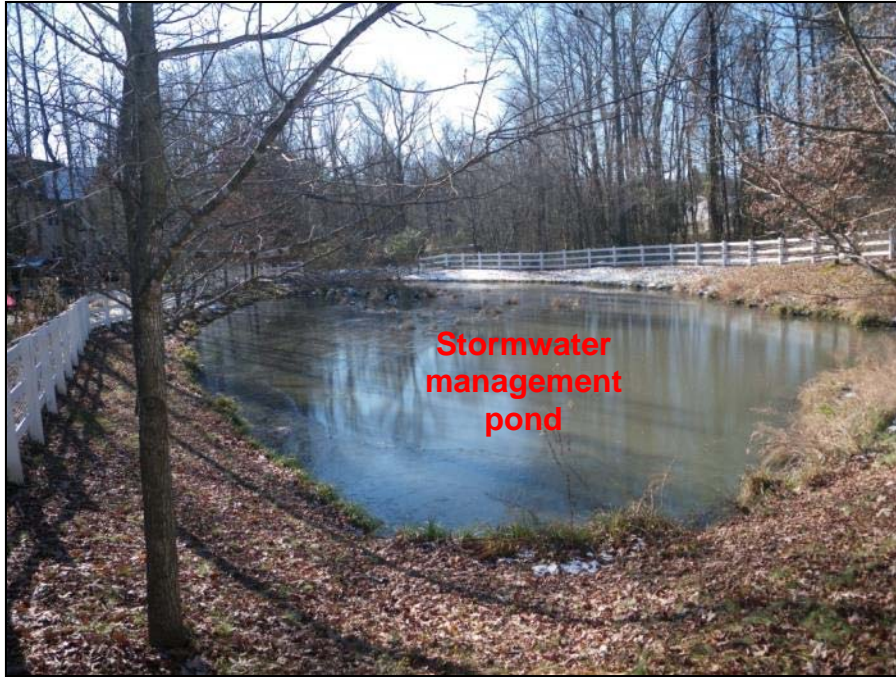
Photograph 55. View of Harness Creek View stormwater management pond.

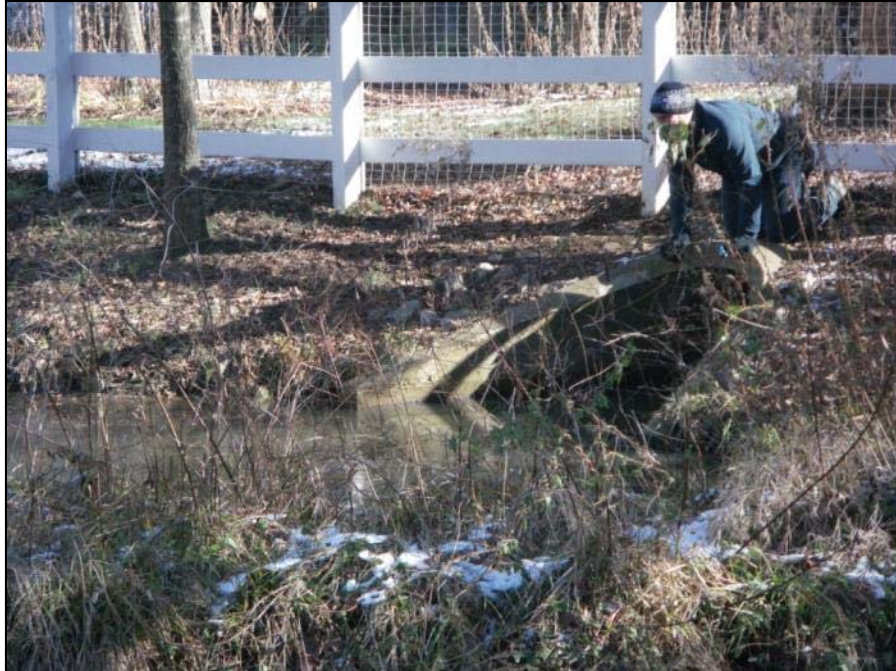
Photograph 56. View of inlet to pond. Note that rip rap was not present at the inlet.

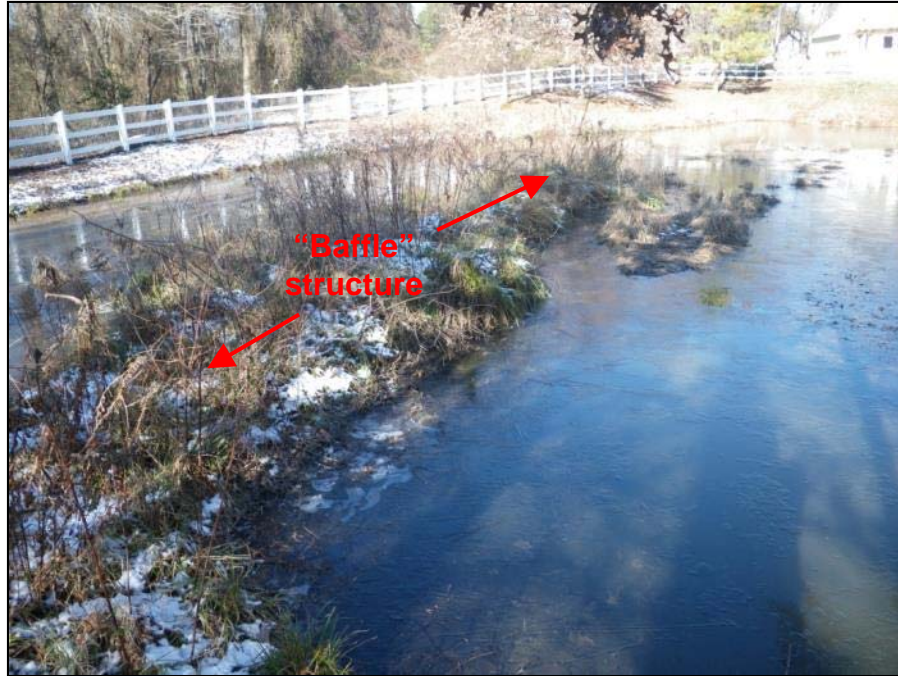
Photograph 57. View of “baffle” structure near the inlet to the pond.

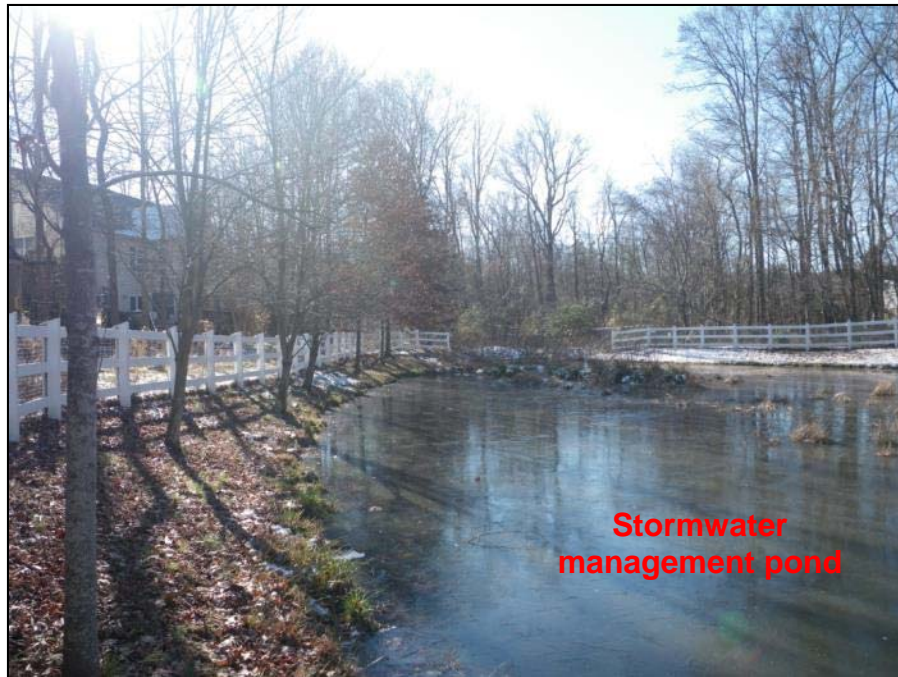
Photograph 58. Additional view of stormwater management pond. Note trees along the eastern bank of the pond.

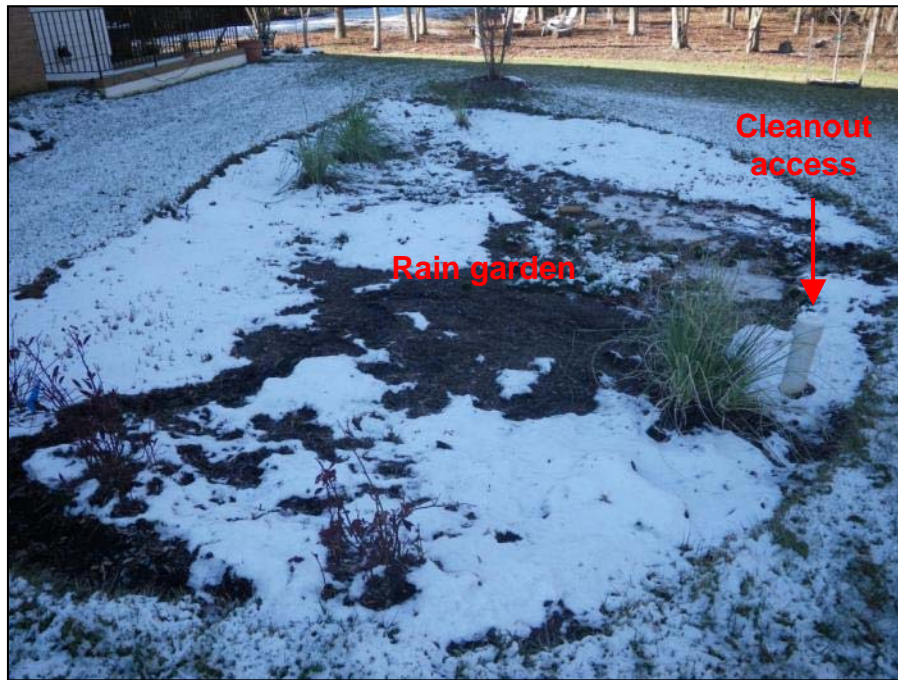
Photograph 59. View of rain garden at 1292 Spa Road.

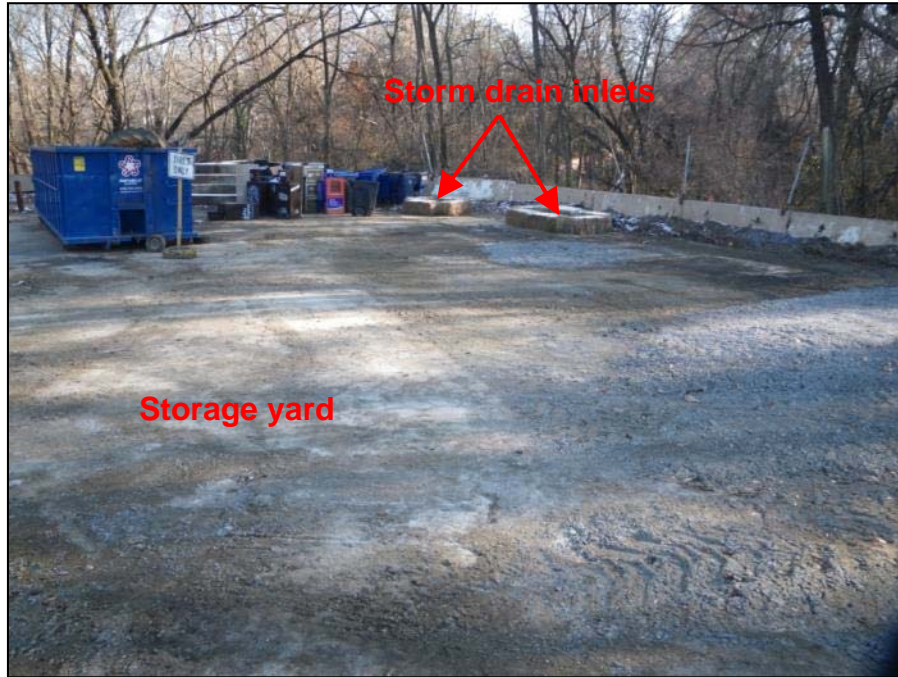
Photograph 60. 935 Spa Road – View of the back storage yard at 935 Spa Road Facility. Note the two storm drain inlets ultimately lead to Spa Creek located immediately to the south of the Spa Creek Facility.
